CORVUS NEVADA GOLD INC.
NORTH BULLFROG PROJECT
PUMPING TESTS: WW-21-02 & WW-21-03
NOVEMBER 2023 – FEBRUARY 2024

MAY 2024

Nevada Division of Water Resources
&
Beatty Water and Sanitation District

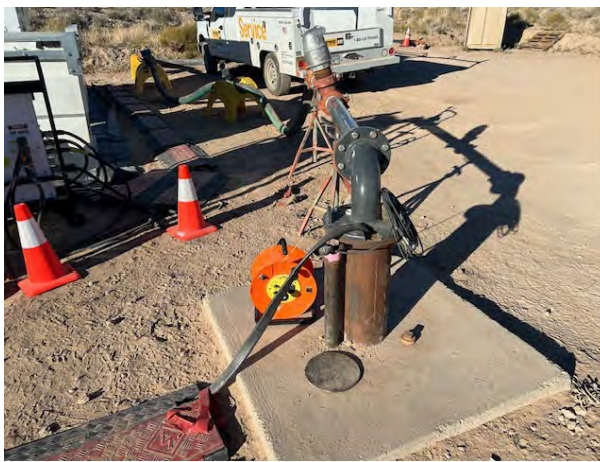
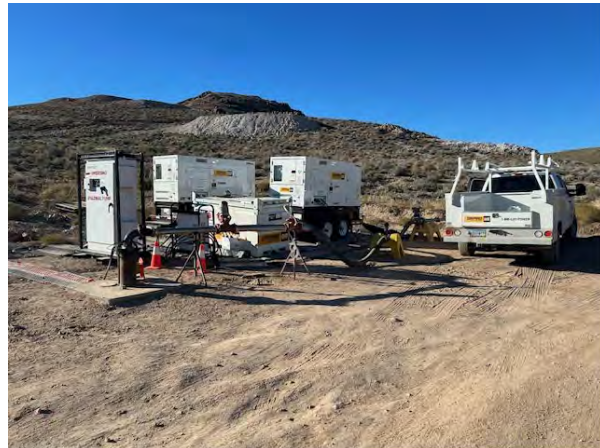
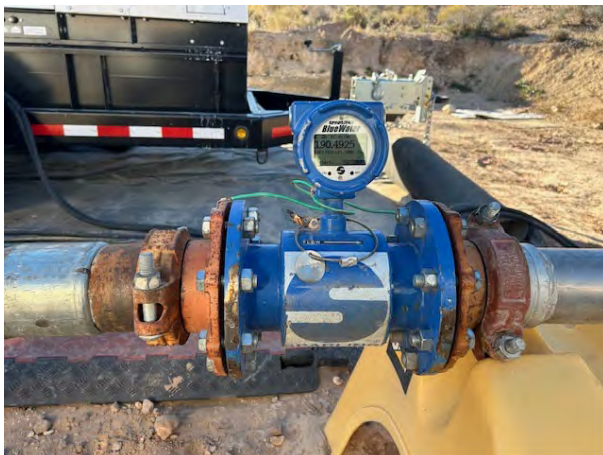
Figure 2:
WW-21-02
Details

TEST #1 (91254T) WW-21-02: DETAILS

- NDWR and BWSO authorization = 75 acre-feet
- Pumping well: WW-21-02
- Test duration: 28-days: 11/8/23 to 12/6/23
- Pumping rate: ~190 gpm over duration of test.
- Supervision: 24/7 coverage at pump and generator. No lost time due to equipment issues.
- Supervision: daylight monitoring measurements and inspections.
- No interruptions to test. Generator cross-over was very quick.
- No safety incidents or environmental releases.
- Weather during test: total precipitation = 0.42"; Temperature = 49F (ave); 58F (ave high)
- **Total Pumped water (step and constant rate testing):
7,708,931 gallons/ 23.66 acre-feet**
- **Unused water: 51.34 acre-feet**

The pump was powered by a CAT generator (with backup generator present) which was designed for variable frequency control. This provided continuous control of the pumping rate and near continuous operation of the pump (minor crossover time to switch generators). The pump and generator installation was temporary. Environmental containment and 24-hour equipment supervision were implemented throughout the testing. Figure 2 shows the site configuration and the operational summary.

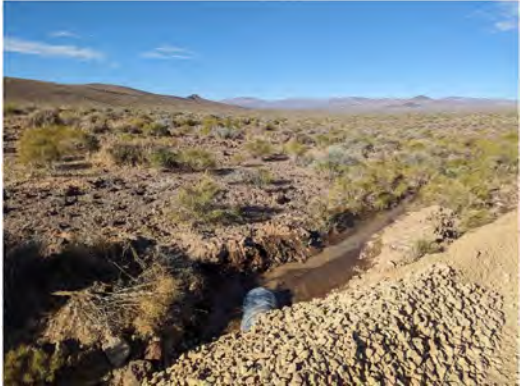
Crossing Strozzi Ranch Road

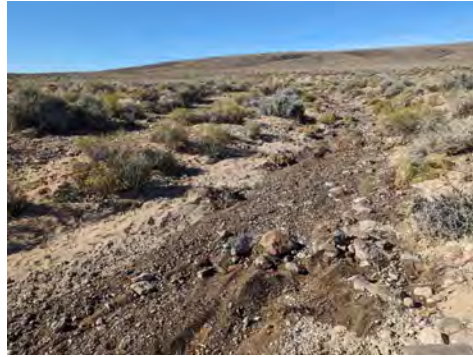
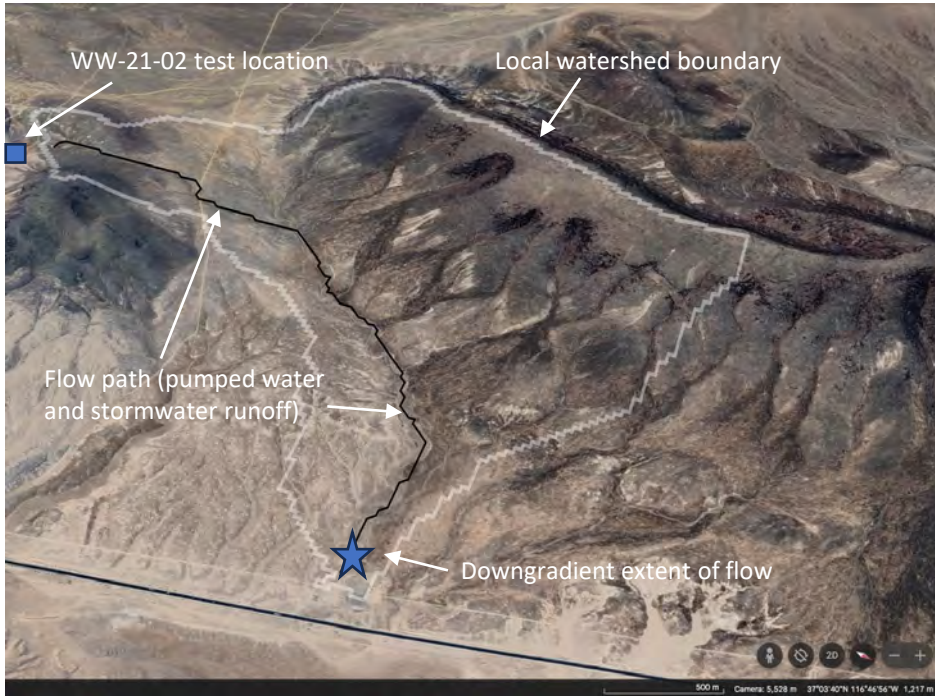
Figure 4: WW-21-02 Flows

Downgradient of Strozzi Ranch road in dry wash near terminus.

TEST #1 (WW-21-02 - 91254T): SURFACE FLOW

- 23.66 acre-feet pumped.
- Flow path was to the north then east along an existing wash/storm water drainage.
- Daily inspection of the discharge flow path to document downgradient extent and sediment control.

- Surface flow stopped as gradient flattened near the US95 RoW.
- Decreasing flow rates along flow path suggested infiltration. >80% discharge of the water is estimated to have been infiltrated.

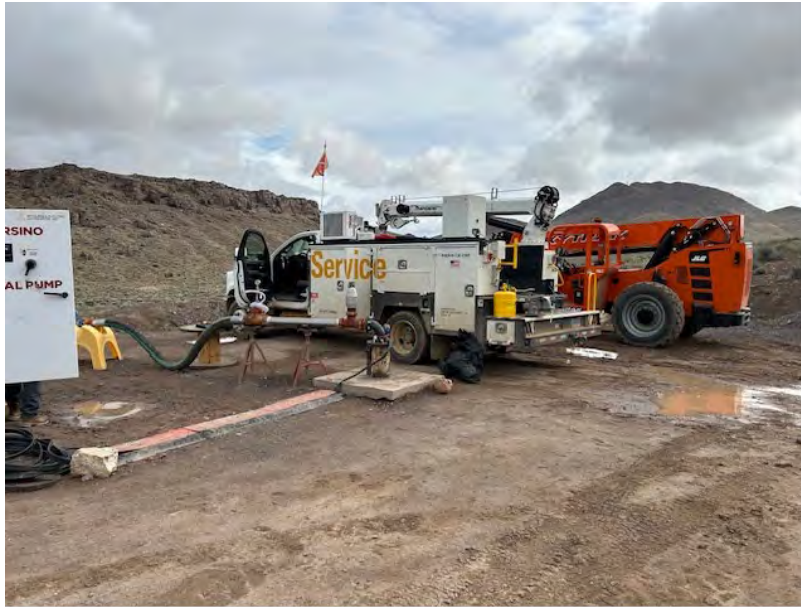
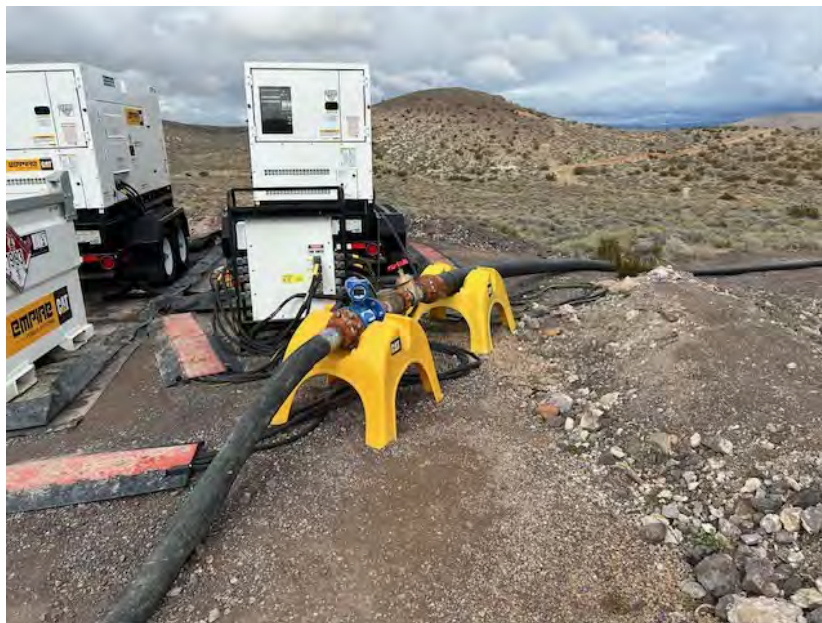
Figure 6:
WW-21-03
Details

TEST #2 (91255T) WW-21-03: DETAILS

- NDWR and BWSD authorization = 75 acre-feet
- Pumping well: WW-21-03
- Test duration: 28-days: 1/23/24 to 2/20/24
- Pumping rate: 248-250 gpm over duration of test
- Supervision: 24/7 coverage at pump and generator
- Supervision: daylight monitoring measurements and inspections.
- No interruptions to test. Generator cross-over was very quick.
- No safety incidents or environmental releases.
- Weather during test: precipitation = 3.75";
Temperature = 43F (ave); 50F (high)
- **Pumped water (step and constant rate testing):
10,186,963 gallons/31.26 acre-feet total**
- ***Unused water: 43.74 acre-feet***

As with WW-21-02, the pump was powered by a CAT generator (with backup generator present) which was designed for variable frequency control. This provided continuous control of the pumping rate and near continuous operation of the pump (minor crossover time to switch generators). The pump and generator installation was temporary. Environmental containment and 24-hour equipment supervision were implemented. Figure 6 shows the site configuration and the operational summary.

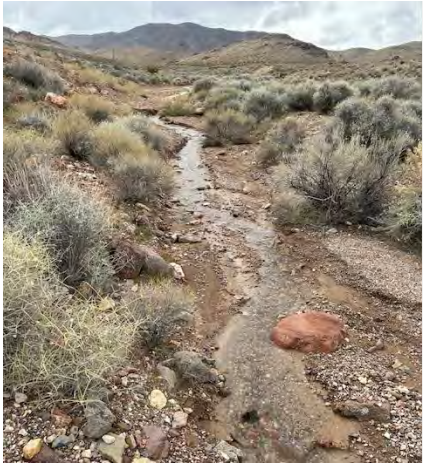
Surface flow from test #2 in existing dry wash (looking west)

The groundwater discharge from the testing phases of the well was routed to a location noted in Figure 9. The figure also includes a short summary of concurrent conditions. This is a natural drainage. Based on the decreasing flow rates along the flow path and the ultimate disappearance of water at the terminus of flow, the test water infiltrated to the shallow colluvium and basin fill deposits along the flow path.

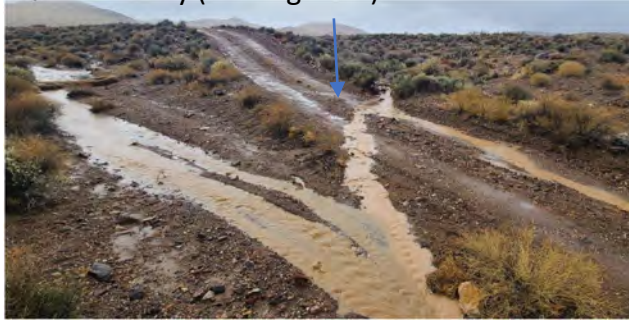
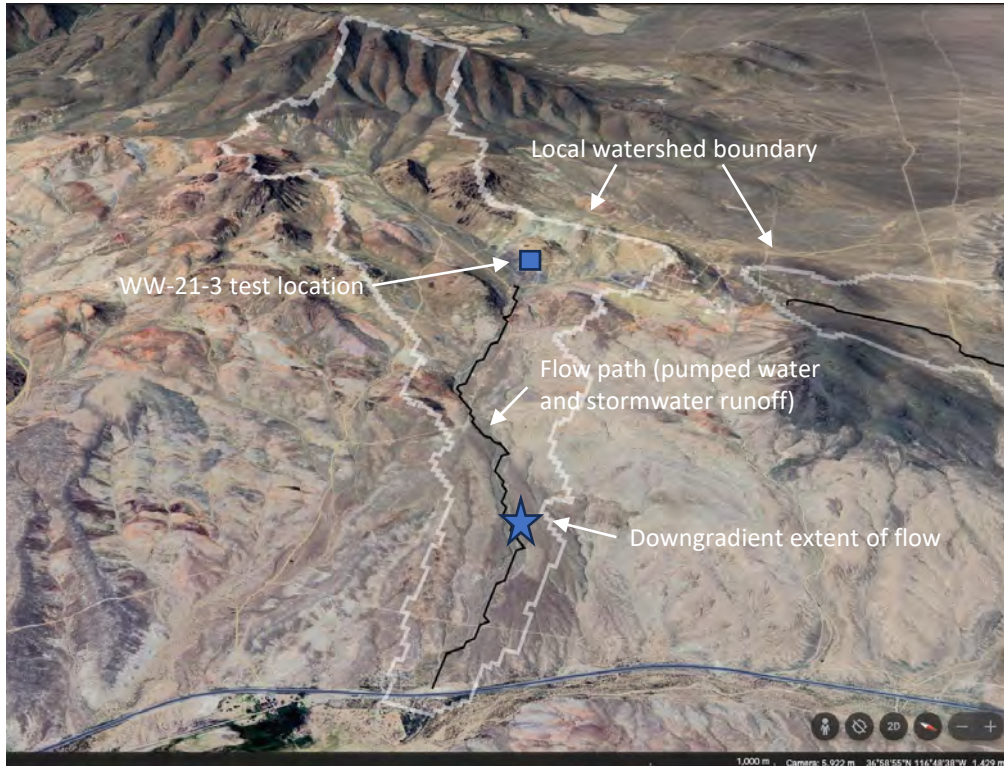
Figure 9: WW-21-03 Flows

Surface flow from test #2 combined with stormwater runoff in early February (looking west)

TEST #2 (WW-21-03 - 91255T): SURFACE FLOW

- 31.26 acre-feet pumped.
- Flow path is to the east along an existing wash/storm water drainage.
- Daily inspection of discharge flow path to document downgradient extent and sediment control.

- Decreasing flow rates along flow path suggested infiltration. >80% discharge of the water is estimated to have been infiltrated.
- Infiltration to surface alluvium and gravels along flow path becomes recharge to shallow 'basin fill aquifer' of Oasis Valley

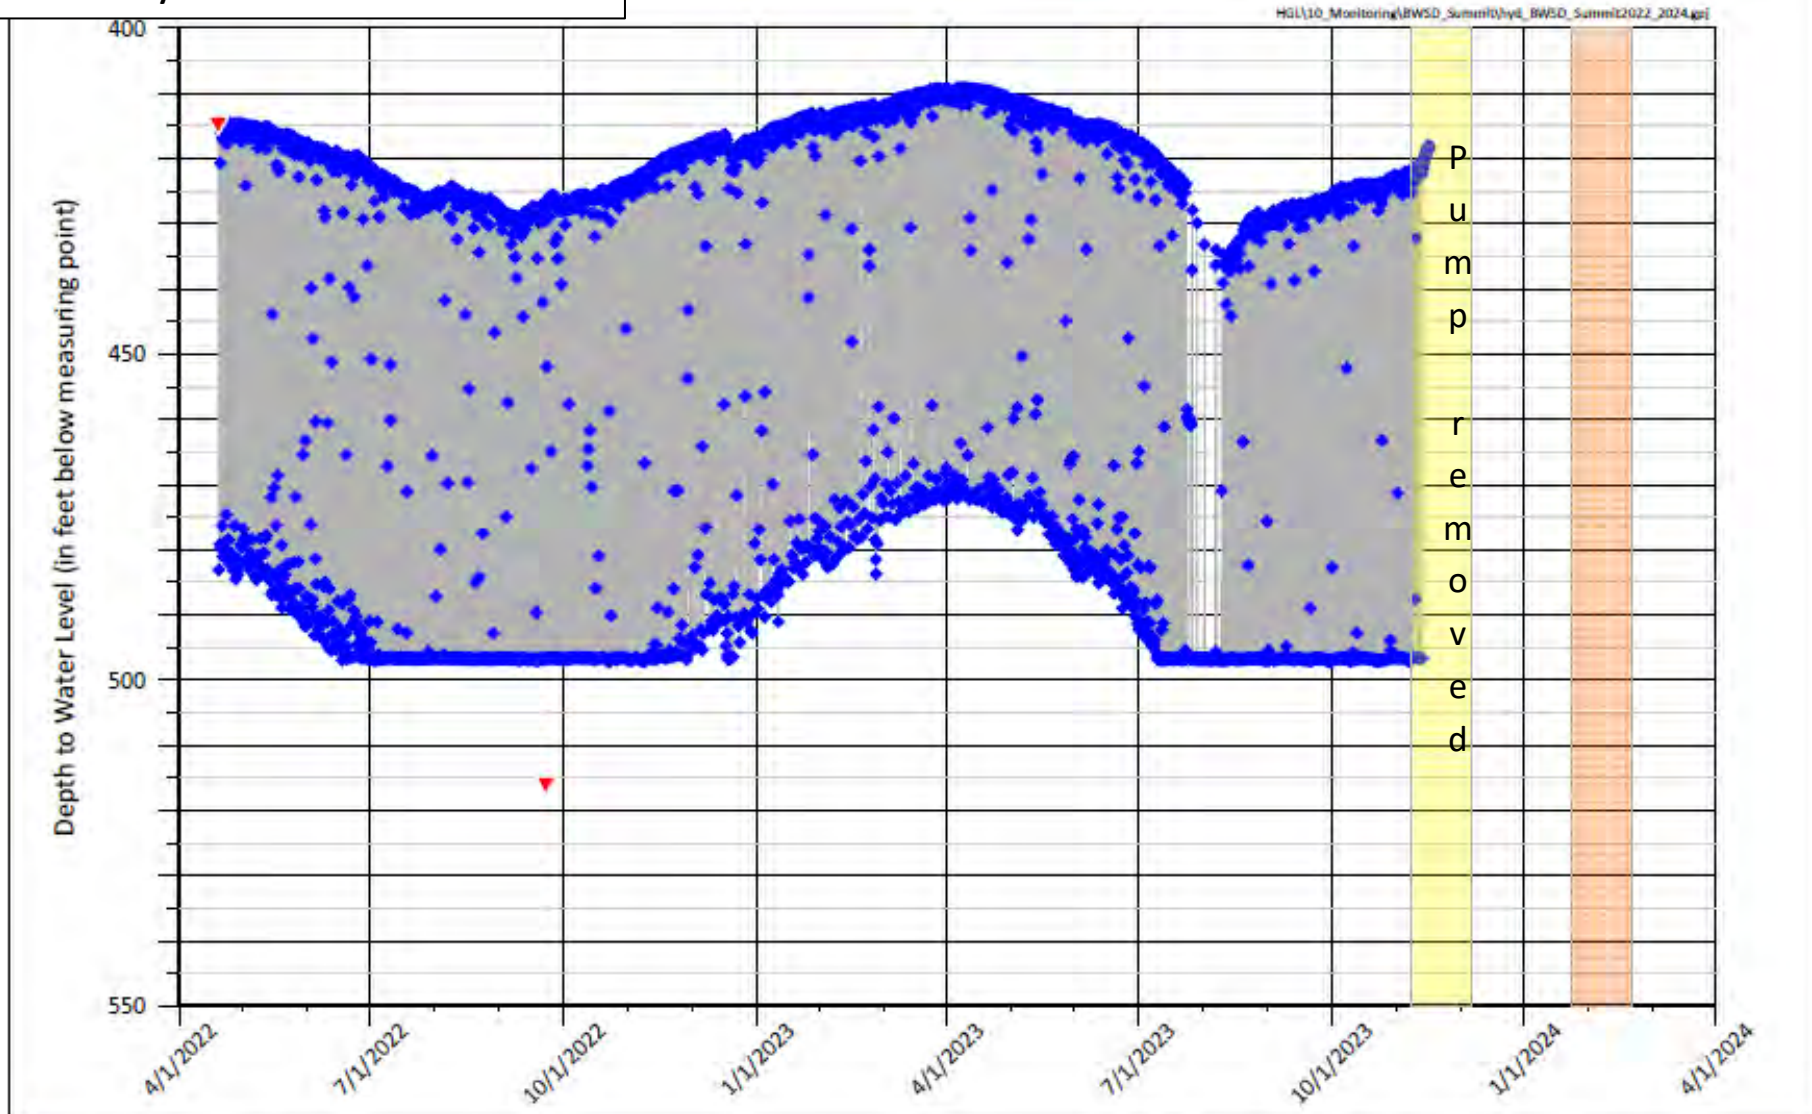
Figure 11: Beatty Summit Well

- Notes: 1) well pumping 44 gpm on 22-Sep-2022 at 11:50 hours
 2) pumping water level below transducer setting (498 ft) during summer and fall seasons
 3) measuring point top of PVC access tube approximately 1 foot above concrete pad
 4) pressure transducer removed 11/16/2023 for pump replacement

The measuring probe in the Beatty Summit well was removed when the pump was removed and serviced in November. It has not yet been replaced and a new installation is under review.

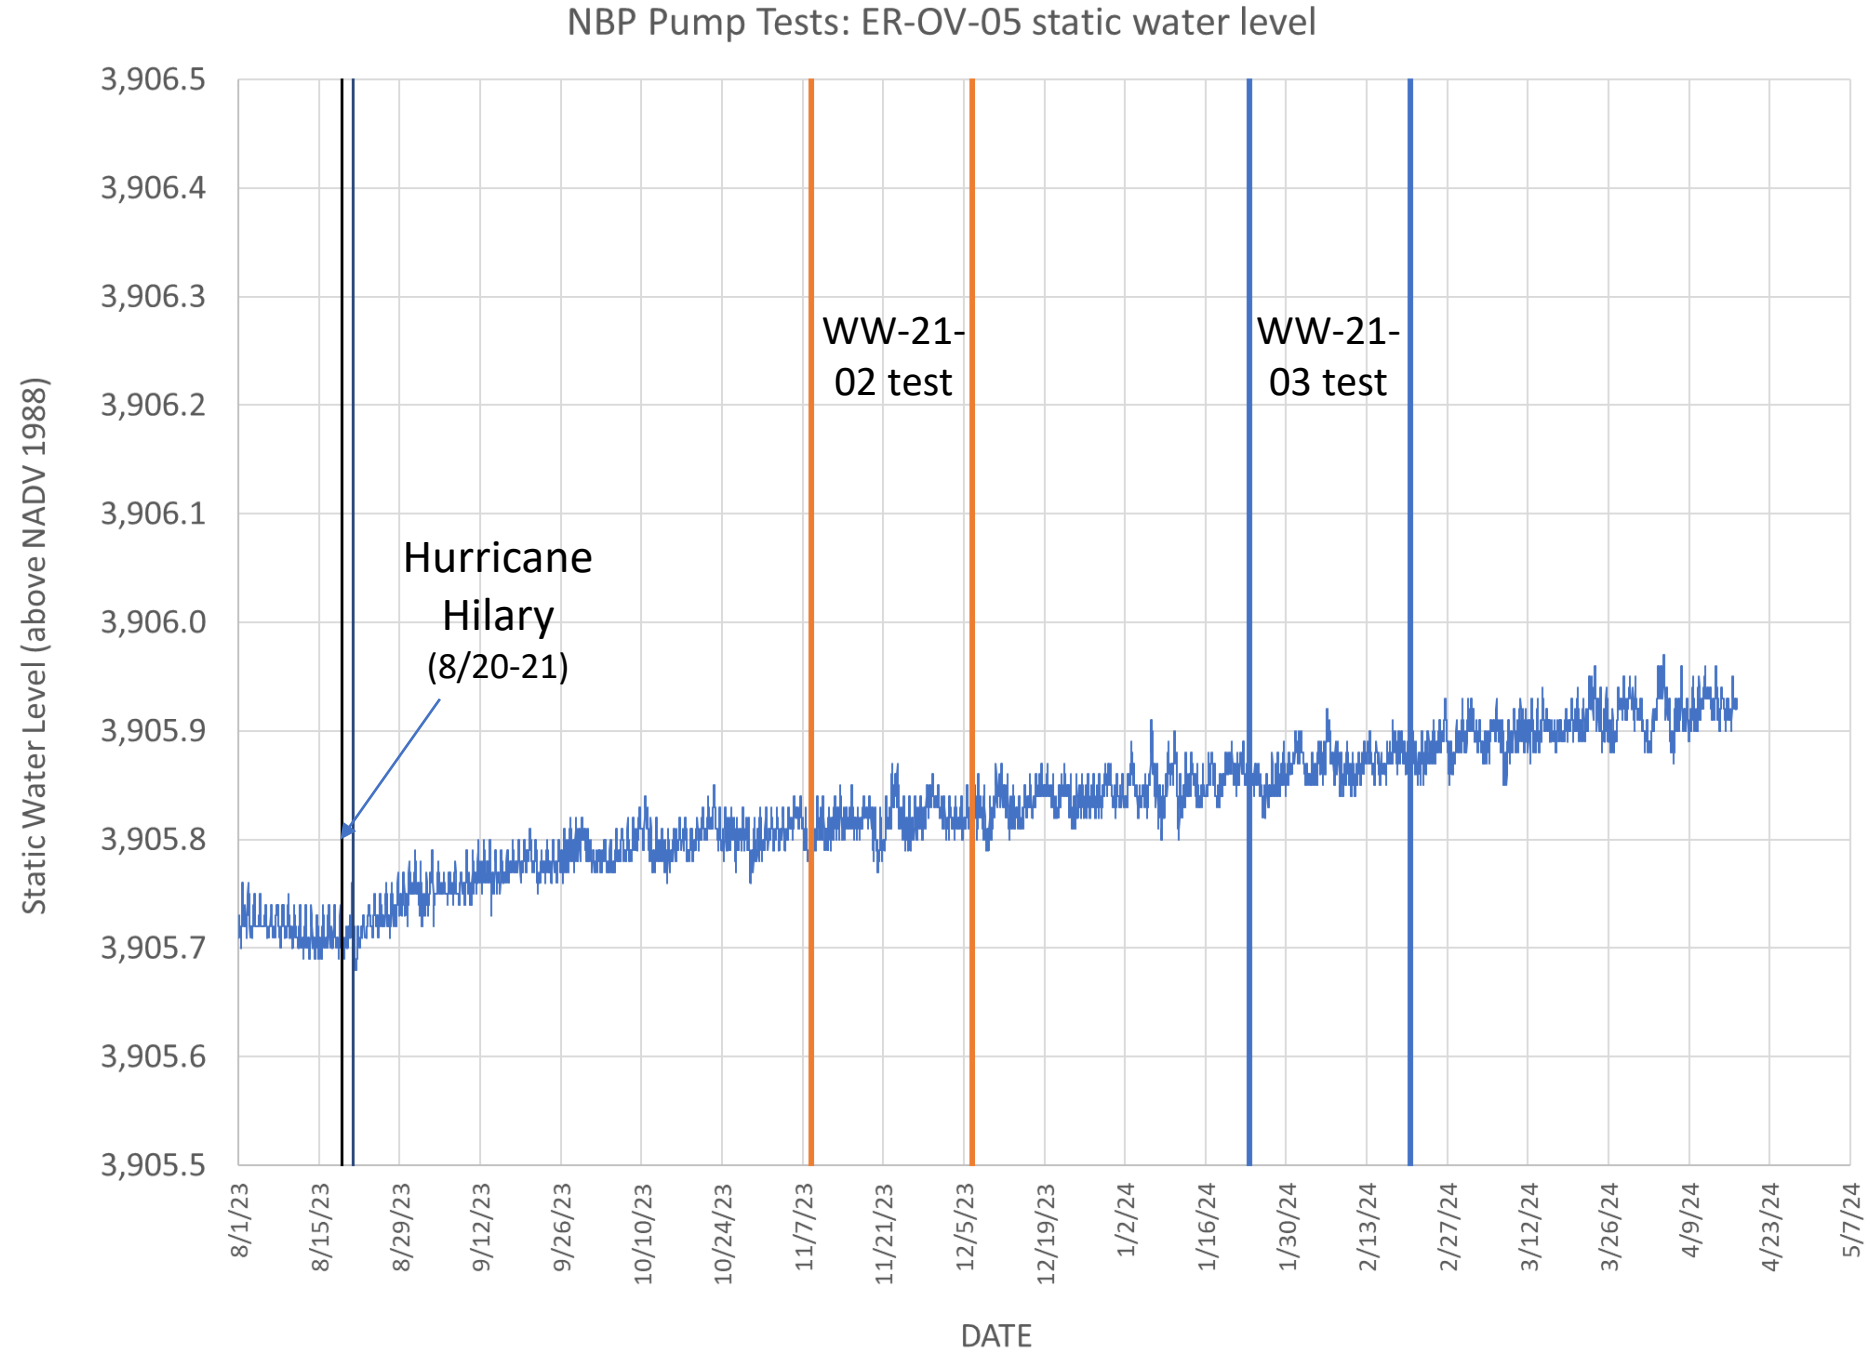
Figure 13: ER-OV-05
2023-2024

- The ER-OV-05 well (Figure 13) showed no discernable response or change the water level from the WW-21-02 or WW-21-03 pumping test activities.
- There was a slight change in the water level trend (increase) following the Hurricane Hilary event of 19-21 August 2023. The typical yearly cycle for ER-OV-05 shows the water level trend generally increasing in the fourth quarter.
- The long-term data are noted in Figure 14.

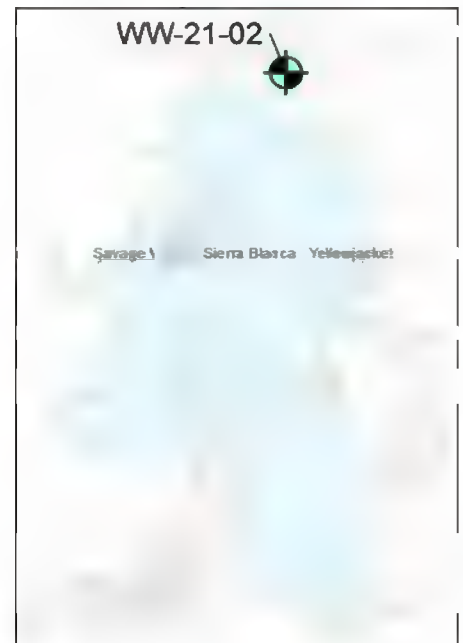
Project: North Bullfrog
Client: Corvus Gold, Inc.
ID: WW-21-02

Borehole Log & Well Construction (As-Built)

Location: North Sierra Blanca
 Northing (NAD27): 4098615.56
 Easting (NAD27): 518140.70
 Ground Surface Elevation (ft amsl): 4158.92
 Drilling and Installation Date
 From: 4/18/2021
 To: 4/28/2021
 Driller: Boart Longyear
 Drilling Method: Dual Tube Flooded Reverse Circulation

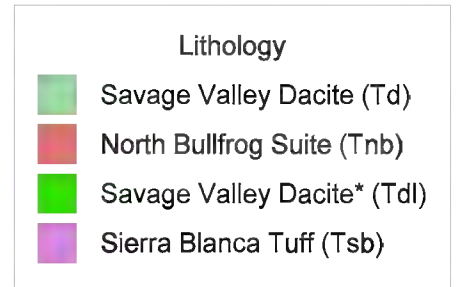
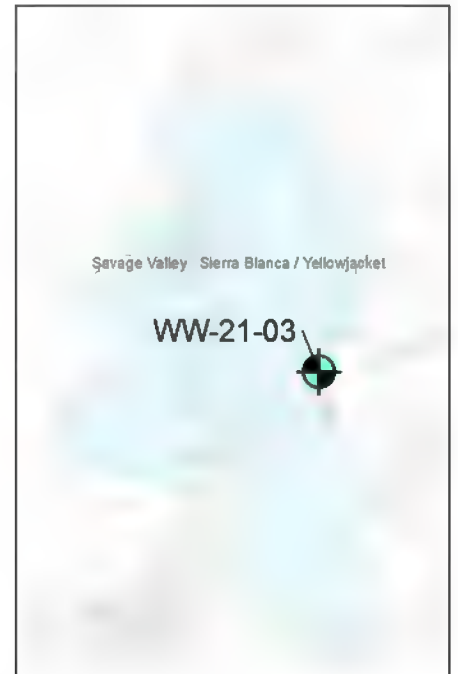
Project: North Bullfrog
Client: Corvus Gold, Inc.
ID: WW-21-03

Borehole Log & Well Construction (As-Built)

Location: East Sierra Blanca
 Northing (NAD27): 4097497.35
 Easting (NAD27): 518287.72
 Ground Surface Elevation (ft. amsl): 4222.33
 Drilling and Installation Date
 From: 4/8/2021
 To: 4/16/2021
 Driller: Boart Longyear
 Drilling Method: Dual Tube Flooded Reverse Circulation

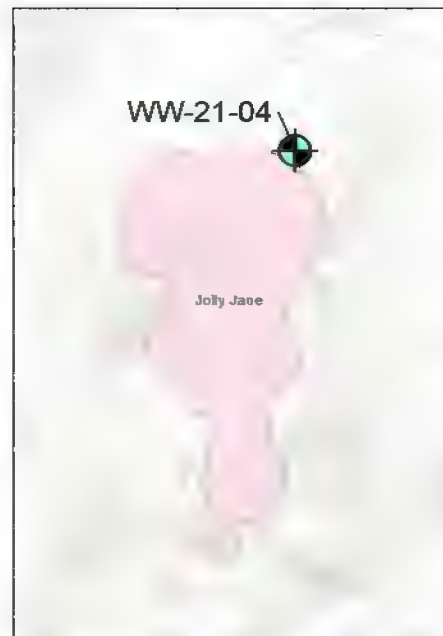
Location: North Jolly Jane
 Northing (NAD27): 4096920.47
 Easting (NAD27): 519231.17
 Ground Surface Elevation (ft. amsl): 4159.14
 Drilling and Installation Dates
 From: 3/29/2021
 To: 4/5/2021
 Driller: Boart Longyear
 Drilling Method: Dual Tube Flooded Reverse Circulation

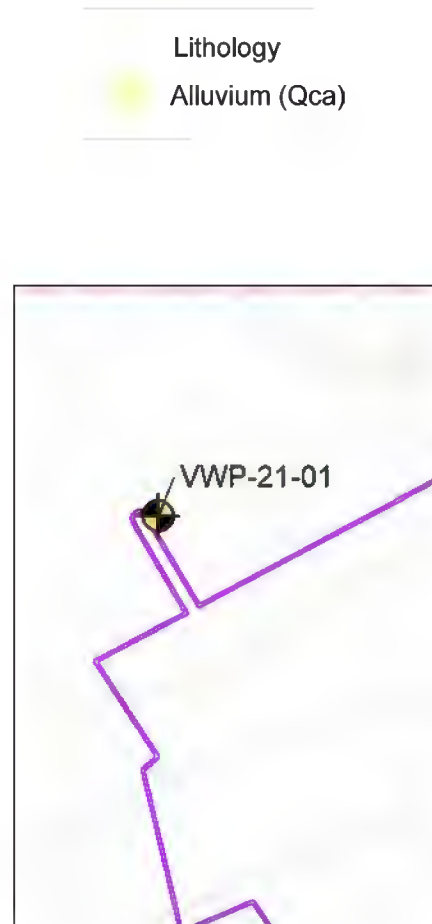
Project: North Bullfrog
Client: Corvus Gold, Inc.
ID: VWP-21-01

Borehole Log & Well Construction (As-Built)

Location: Sarcobatus Flats
 Northing (NAD27): 4099859.83
 Easting (NAD27): 513702.03
 Ground Surface Elevation (ft amsl): 4083.08
 Drilling and Installation Date
 From: 4/25/2021
 To: 4/28/2021
 Driller: Boart Longyear
 Drilling Method: Reverse Circulation

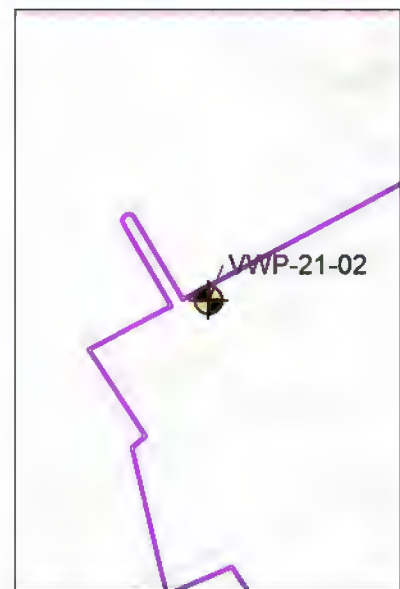
Location: Sarcobatus Flats
Northing (NAD27): 4099469.30
Easting (NAD27): 514001.13
Ground Surface Elevation (ft. amsl): 4093.57
Drilling and Installation Date
From: 4/29/2021
To: 4/30/2021
Driller: Boart Longyear
Drilling Method: Reverse Circulation

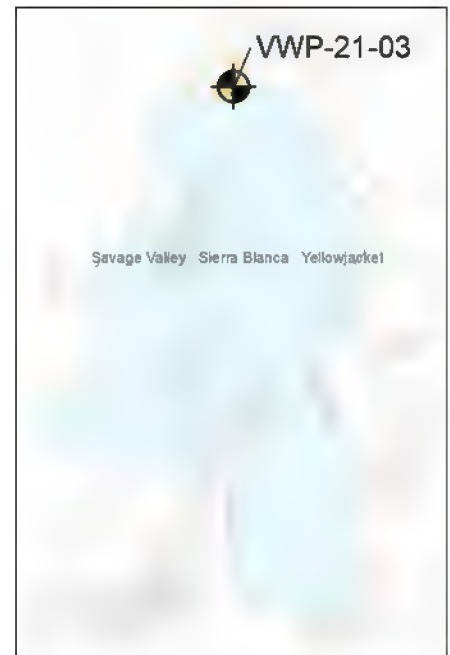
Location: North Sierra Blanca
Northing (NAD27): 4098563.52
Easting (NAD27): 517962.24
Ground Surface Elevation (ft. amsl): 4185.72
Drilling and Installation Date
From: 4/12/2021
To: 4/24/2021
Driller: Boart Longyear
Drilling Method: Reverse Circulation

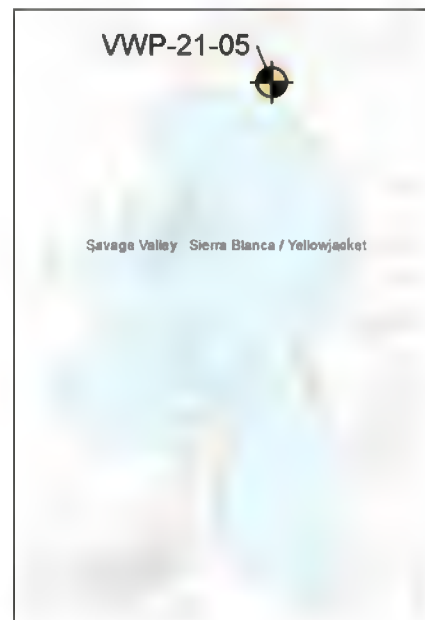
Location: North Sierra Blanca
 Northing (NAD27): 4098571.89
 Easting (NAD27): 518163.04
 Ground Surface Elevation (ft. amsl): 4169.36
 Drilling and Installation Date
 From: 4/4/2021
 To: 4/9/2021
 Driller: Boart Longyear
 Drilling Method: Reverse Circulation

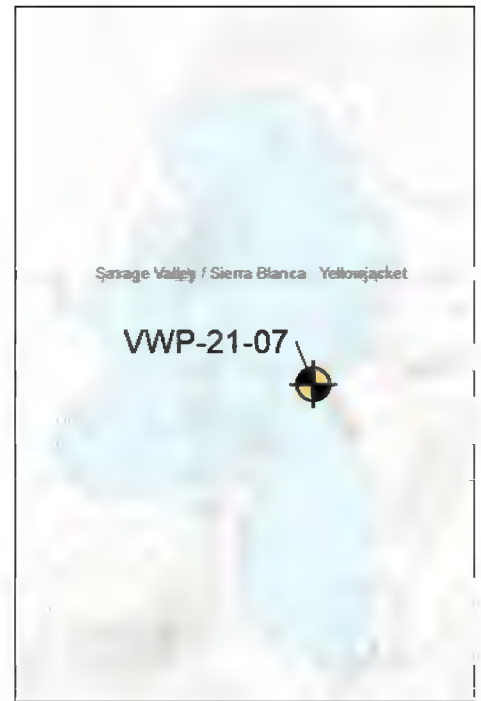
* = Lower Mixed Clastic Member
' = Basal Layer

Note: All depths are in feet below ground surface

Location: East Sierra Blanca
Northing (NAD27): 4097502.75
Easting (NAD27): 518203.12
Ground Surface Elevation (ft. amsl): 4266.88
Drilling and Installation Date
From: 4/1/2021
To: 4/3/2021
Driller: Boart Longyear
Drilling Method: Reverse Circulation

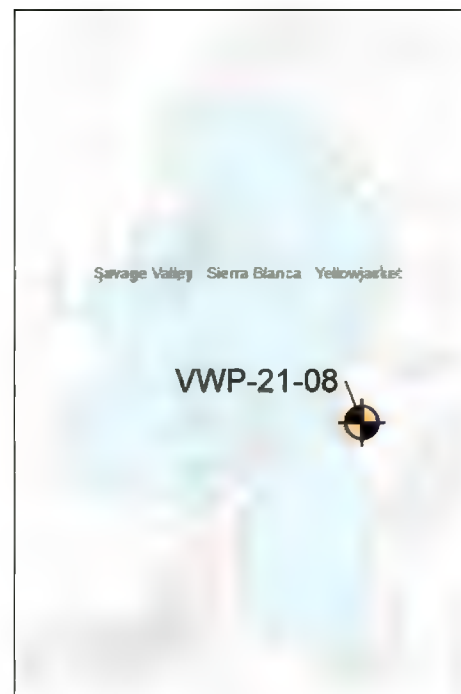
* = Lower Mixed Clastic Member
** = Dacite Dike

Note: All depths are in feet below ground surface

Location: East Sierra Blanca
Northing (NAD27): 4097356.35
Easting (NAD27): 518401.02
Ground Surface Elevation (ft. amsl): 4191.89
Drilling and Installation Date
From: 3/17/2021
To: 3/21/2021
Driller: Boart Longyear
Drilling Method: Reverse Circulation

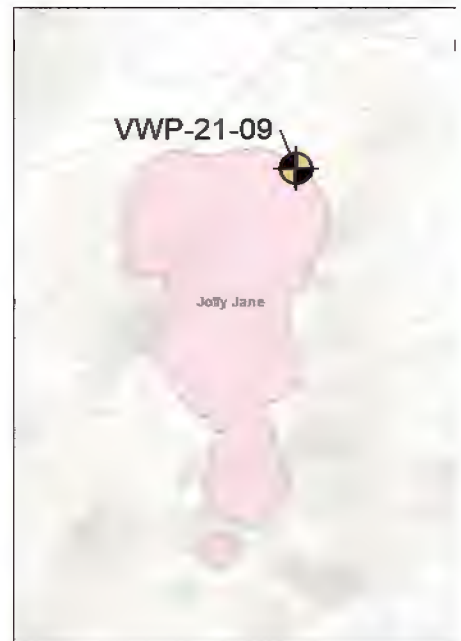
Project: North Bullfrog
Client: Corvus Gold, Inc.
ID: VWP-21-09

` = Hematic Sediments
* = Lower Mixed Clastic Member

Note: All depths are in feet below ground surface

Location: North Jolly Jane
Northing (NAD27): 4096880.53
Easting (NAD27): 519227.98
Ground Surface Elevation (ft. amsl): 1269.33
Drilling and Installation Date
From: 3/13/2021
To: 3/16/2021
Driller: Boart Longyear
Drilling Method: Reverse Circulation

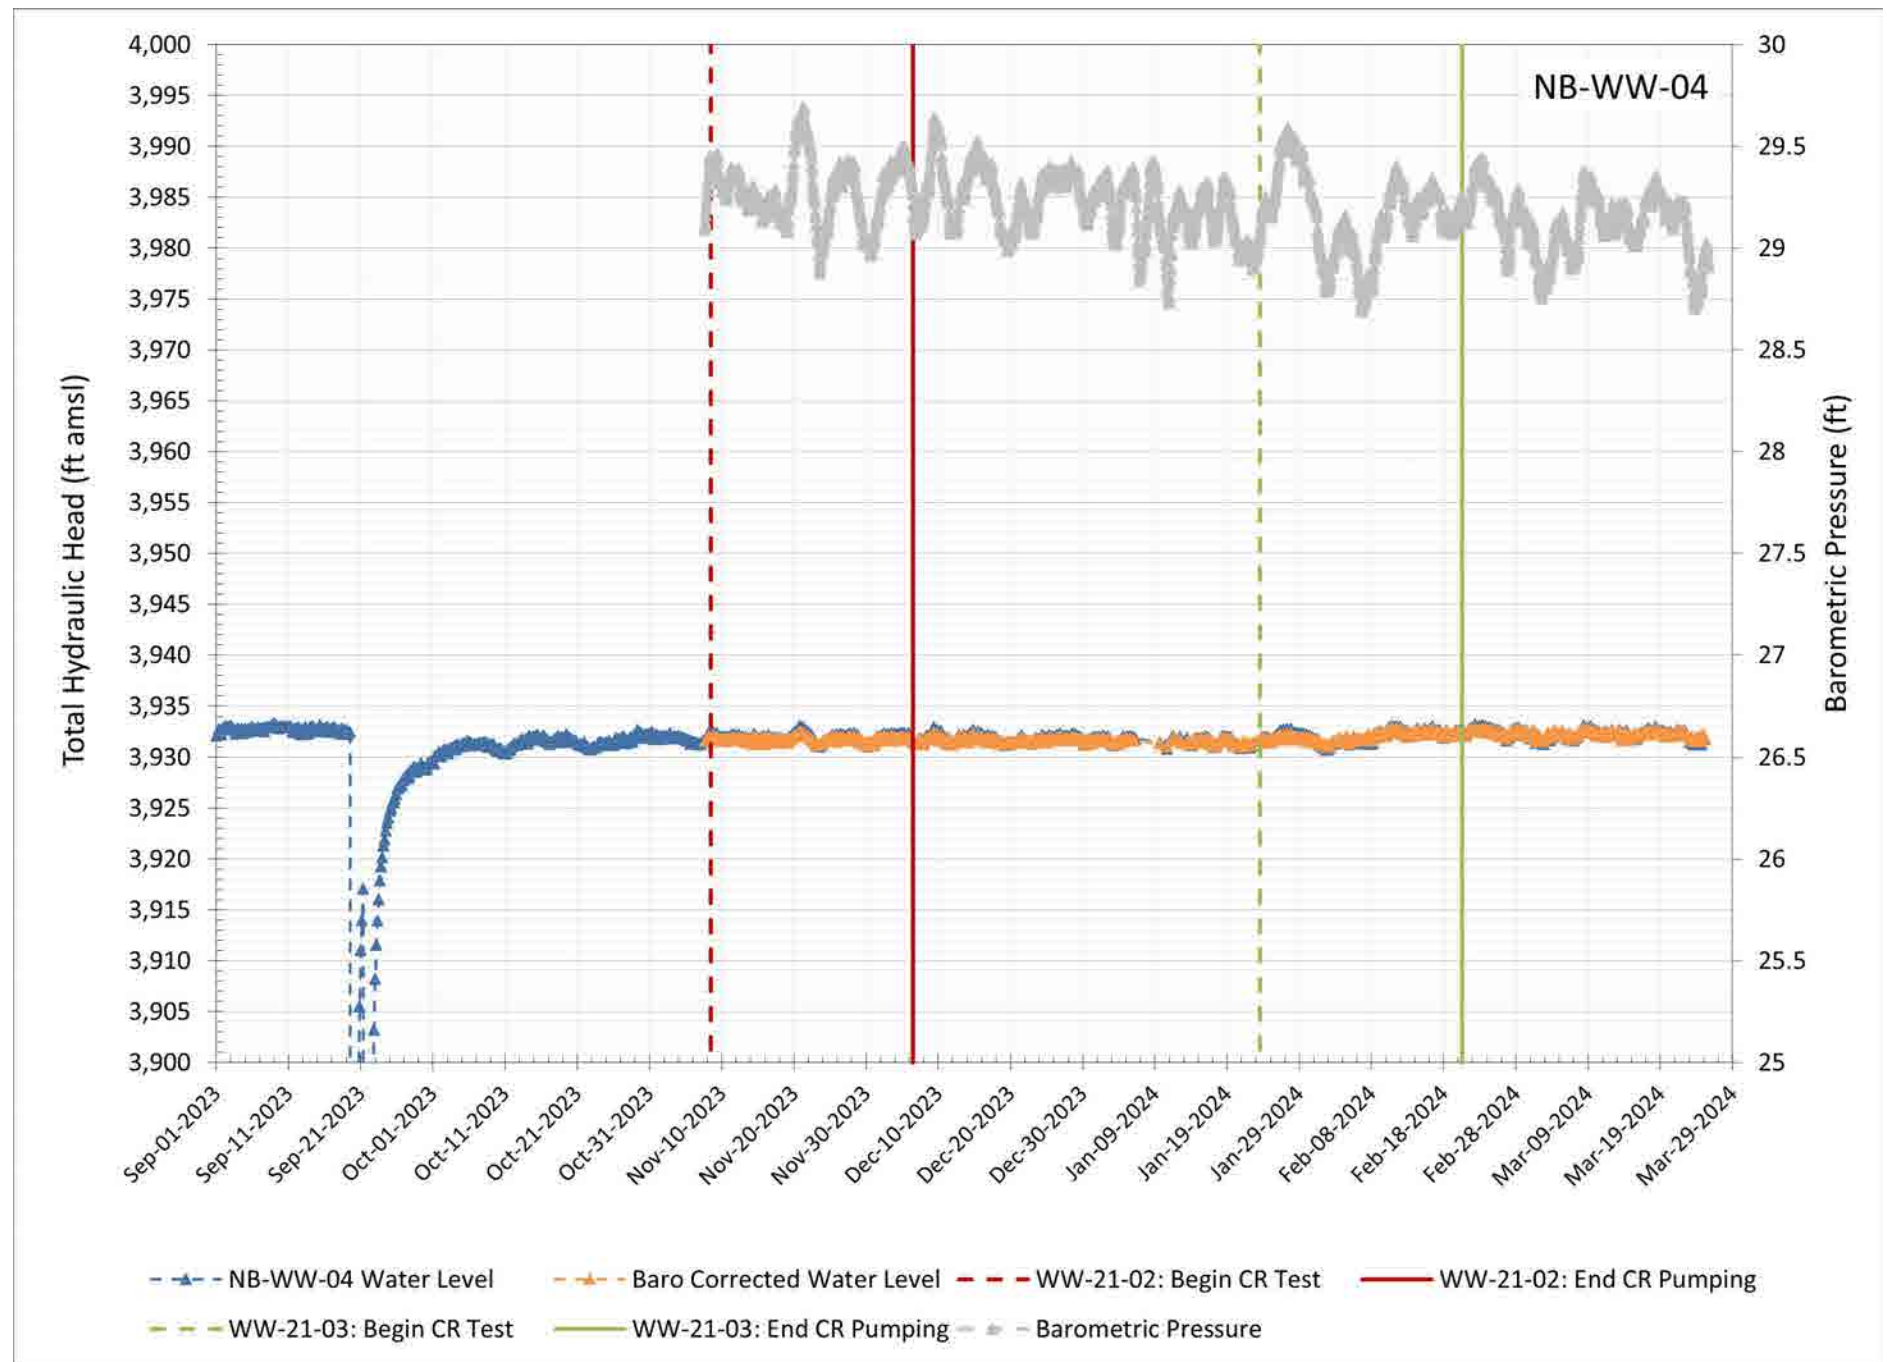
NB-WW-04		
Elevation Land Surface	ft amsl	4237
Total Depth Drilled	ft	598
Well Screen Depth	ft	498 to 598

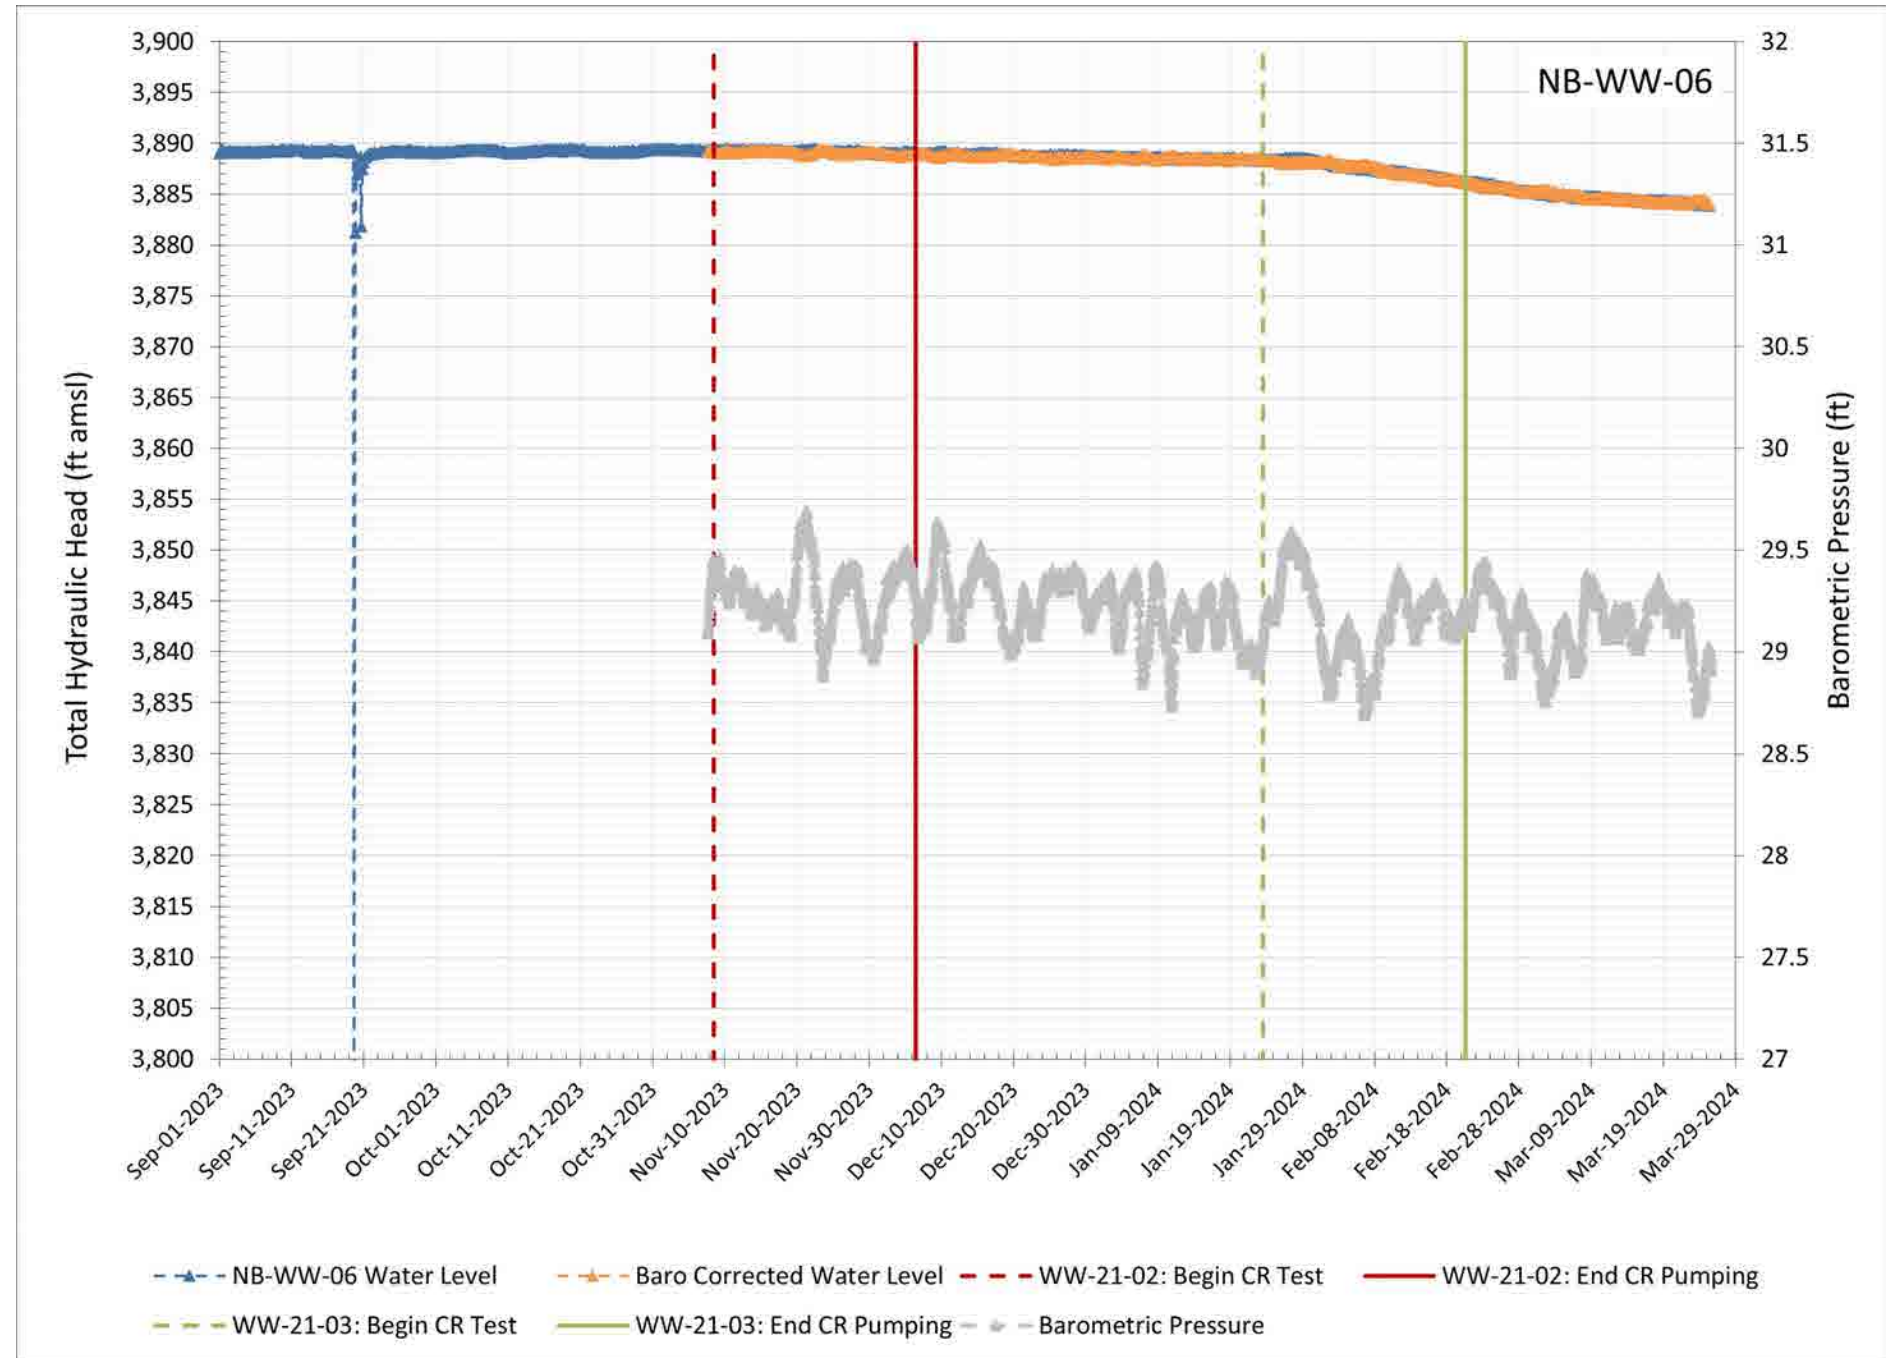
NB-WW-06		
Elevation Land Surface	ft amsl	4339
Total Depth Drilled	ft	600
Well Screen Depth	ft	498 to 600

- ▲- NB-WW-06 Water Level
 -▲- Baro Corrected Water Level
- - - WW-21-02: Begin CR Test
- - - WW-21-02: End CR Pumping
- - - WW-21-03: Begin CR Test
 - - - WW-21-03: End CR Pumping
-▲- Barometric Pressure
